# Reflective Crack Mitigation Guide for Flexible Pavements Final Report

# Reflective Crack Mitigation Guide for Flexible Pavements

**Final Report**  
**September 2015**

**Sponsored by**  
Iowa Highway Research Board  
(IHRB Project TR-641)  
Iowa Department of Transportation  
(InTrans Project 11-424)

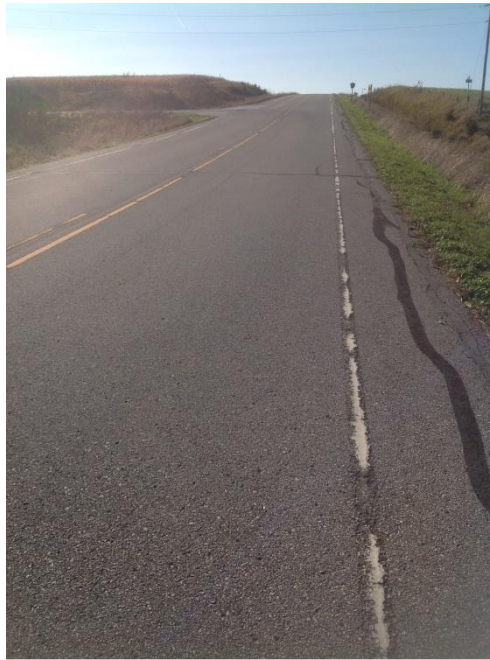
Reflective/transverse cracking pops out in a few locations meters in medium size and cracks were sealed. Longitudinal cracking is whole along the shoulder.

**Figure 54. Performance condition on H14 project**
